## Instytut Techniki Budowlanej

# TEST REPORT

## LZP02-000505/26/Z00NZP

| <b>Test specimen:<br/>(provided by the Client)</b> | Non-loadbearing wall of Rapido Lehmkartonplatte<br>800 |

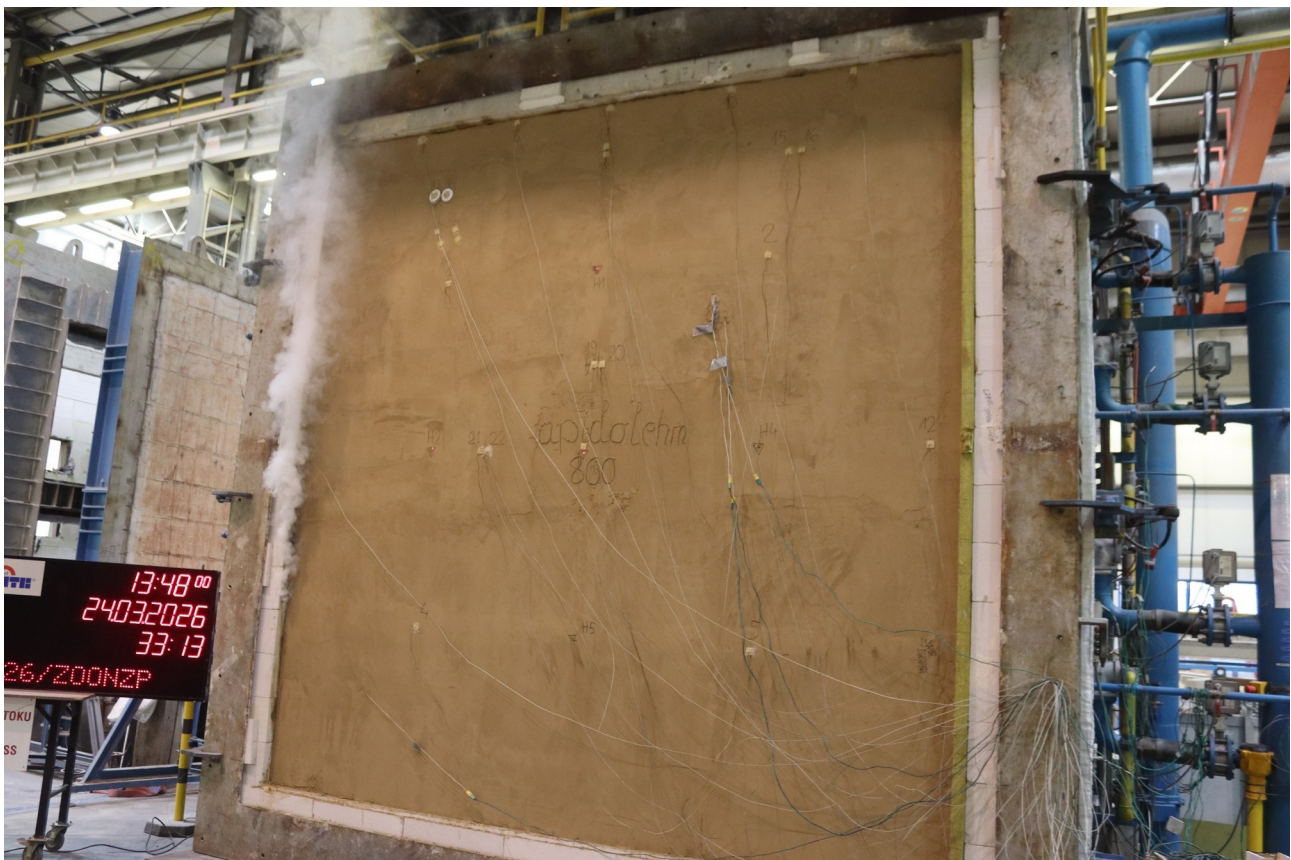
Fig. 14. Unexposed side of the test specimen,  $t = 33 \text{ min } 13 \text{ s}$

| Time | Type | Record |
|---|---|---|
| 32 min 00 s | U | rise of steam and smoke release from vertical and upper specimen fixed edges - see photo on Fig. 14 |

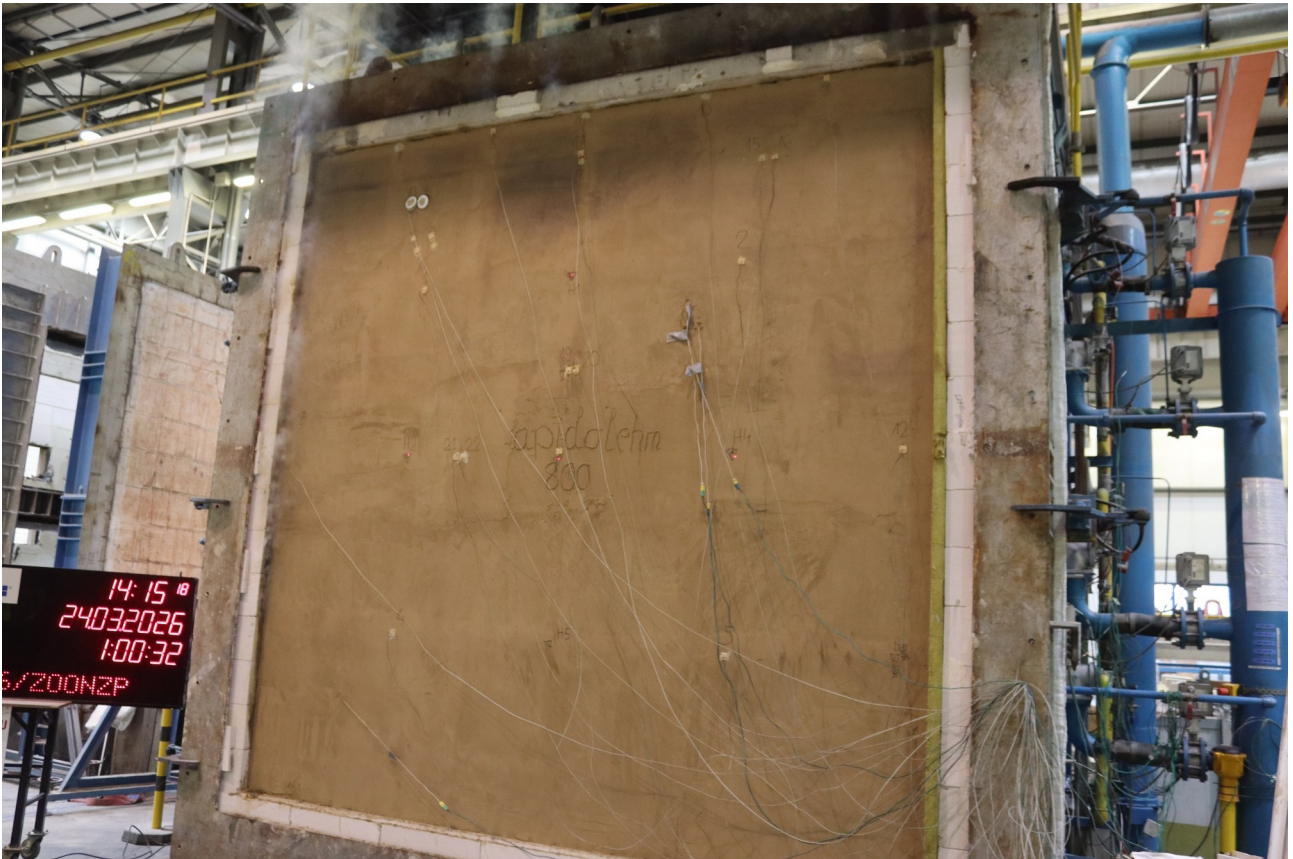
Fig. 15. Unexposed side of the test specimen,  $t = 60 \text{ min } 32 \text{ s}$

| Time | Type | Record |
|---|---|---|
| 60 min 00 s | U | beginning darkening of the plaster close to thermocouple TE18 - see photo on Fig. 15 |

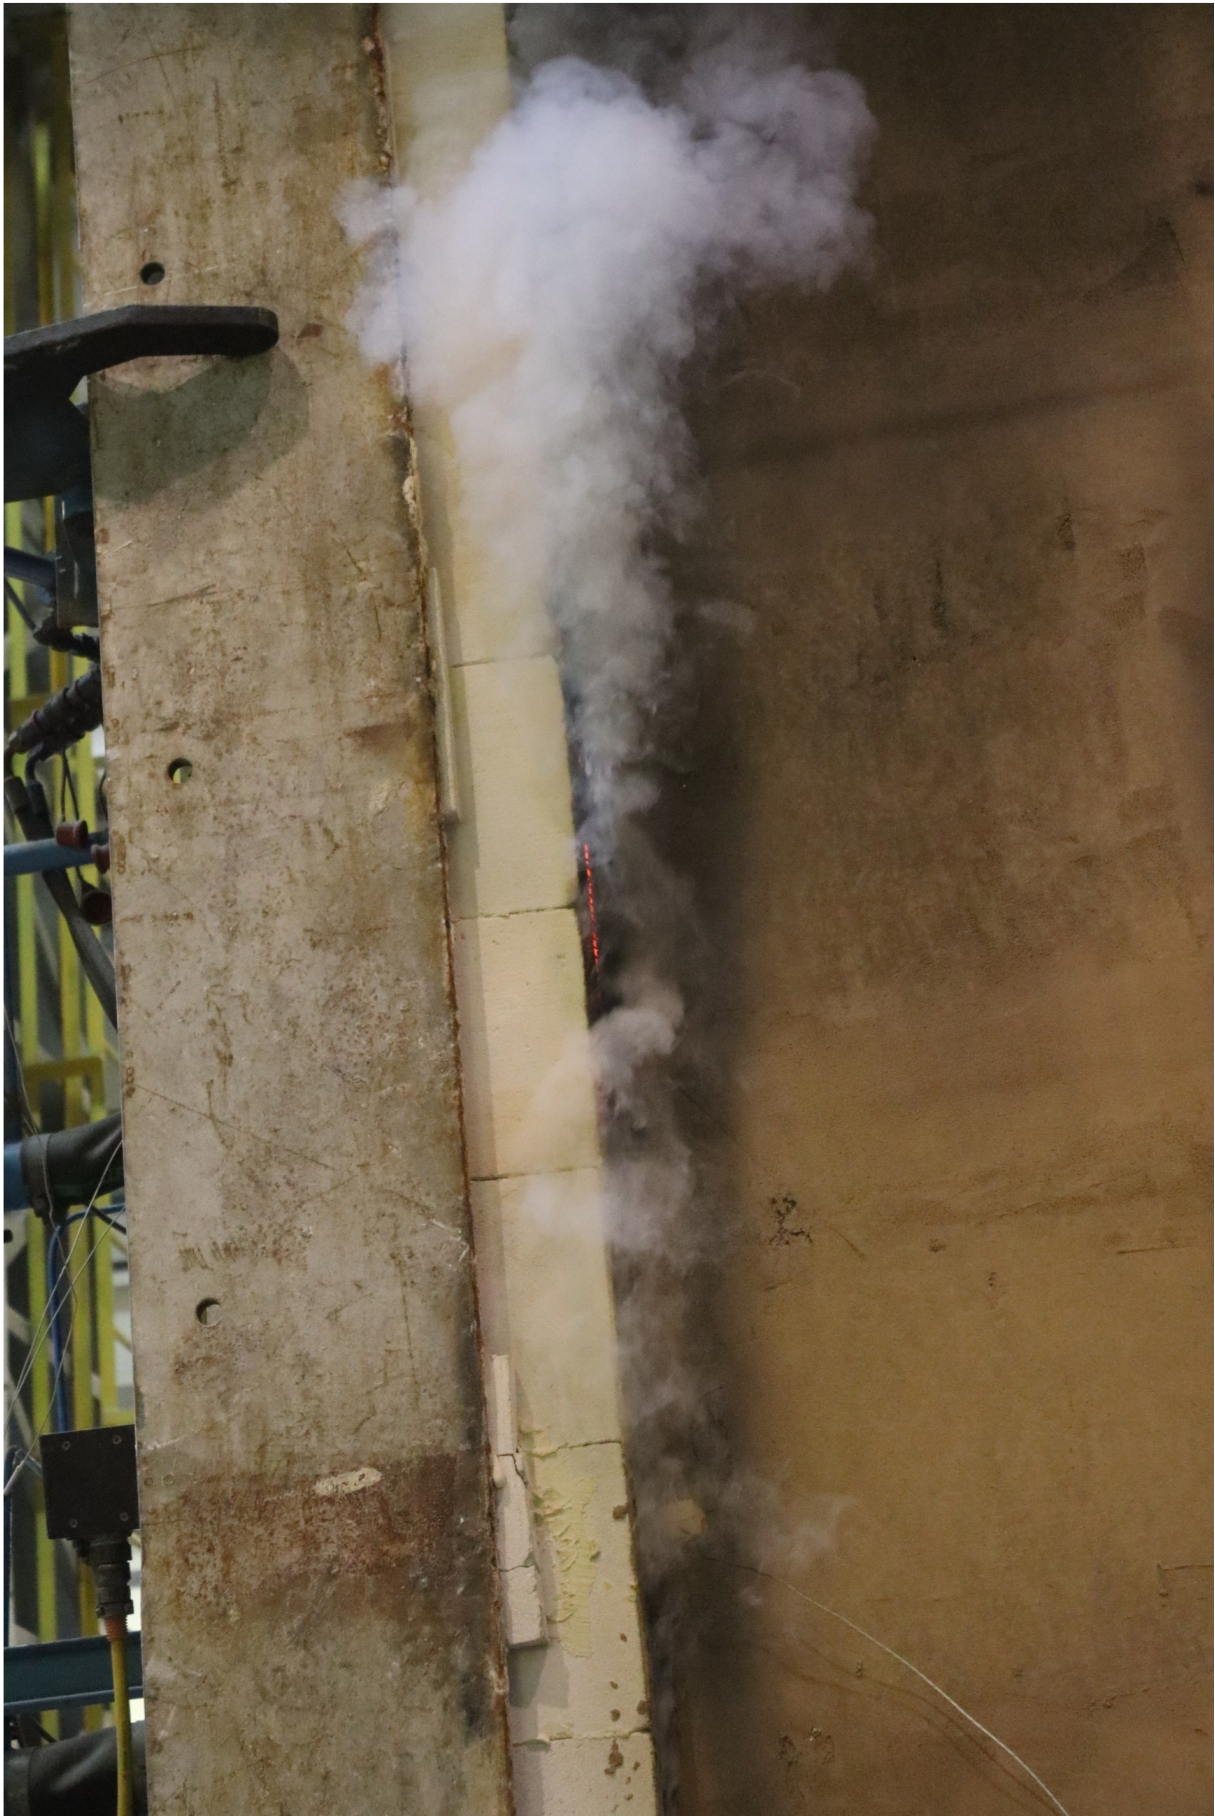
Fig. 19. Unexposed side of the test specimen,  $t = 120 \text{ min } 02 \text{ s}$

| Time | Type | Record |
|---|---|---|
| 119 min 30 s | U | single flame tongues lasted for max 3 seconds at the vertical fixed edge above thermocouple TE6 - see photo on Fig. 19 |

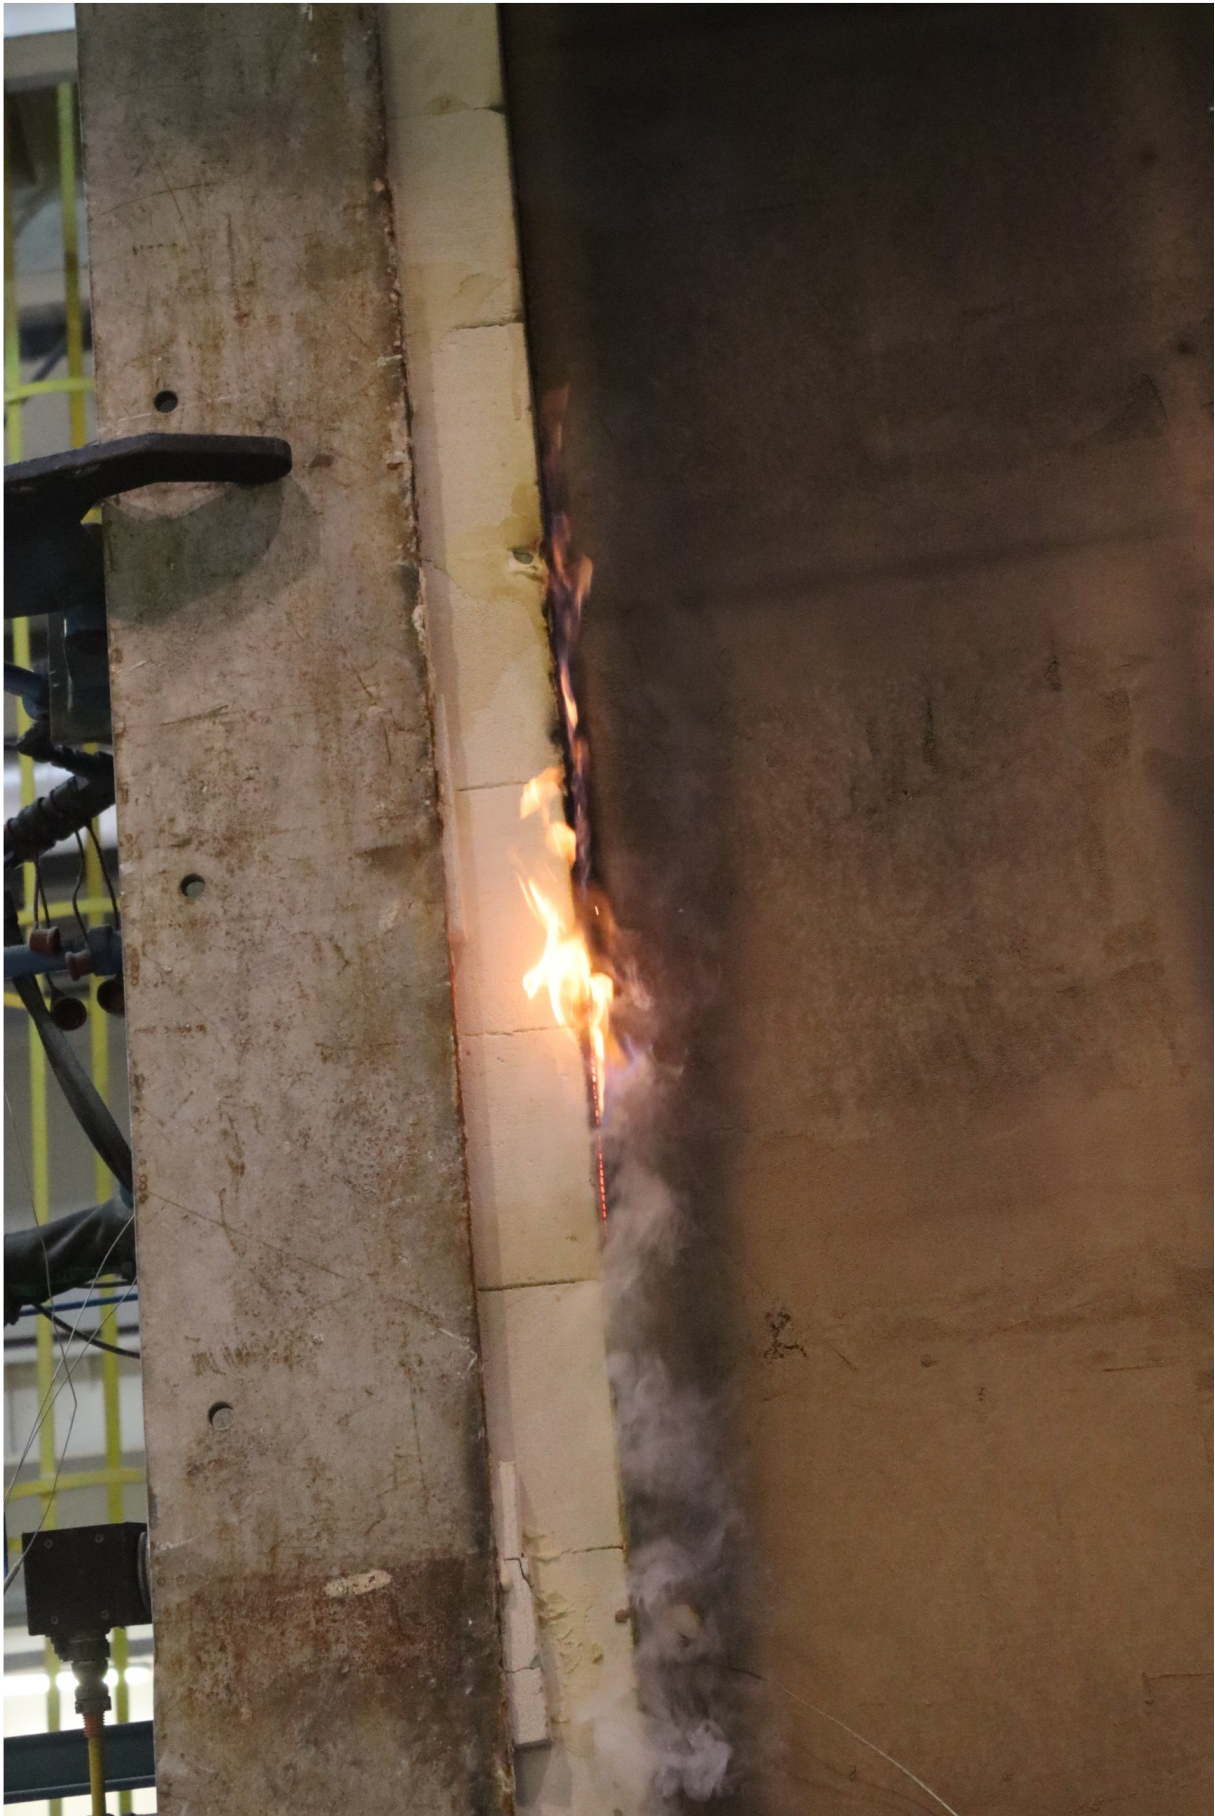
Fig. 20. Unexposed side of the test specimen,  $t = 121 \text{ min } 01 \text{ s}$

| Time | Type | Record |
|---|---|---|
| 120 min 49 s | U | beginning of continuous flame of 12 seconds on unexposed surface at the vertical fixed edge above thermocouple TE6 - see photo on Fig. 20 |

| Integrity performance (E) | Time | Location |
|---|---|---|
| Sustained flaming | 120 minutes | fixed vertical edge |
